European Union Network for the Implementation
and Enforcement of Environmental Law

In Situ Chemical Oxidation – Case studies

IMPEL Project no. 2020/09

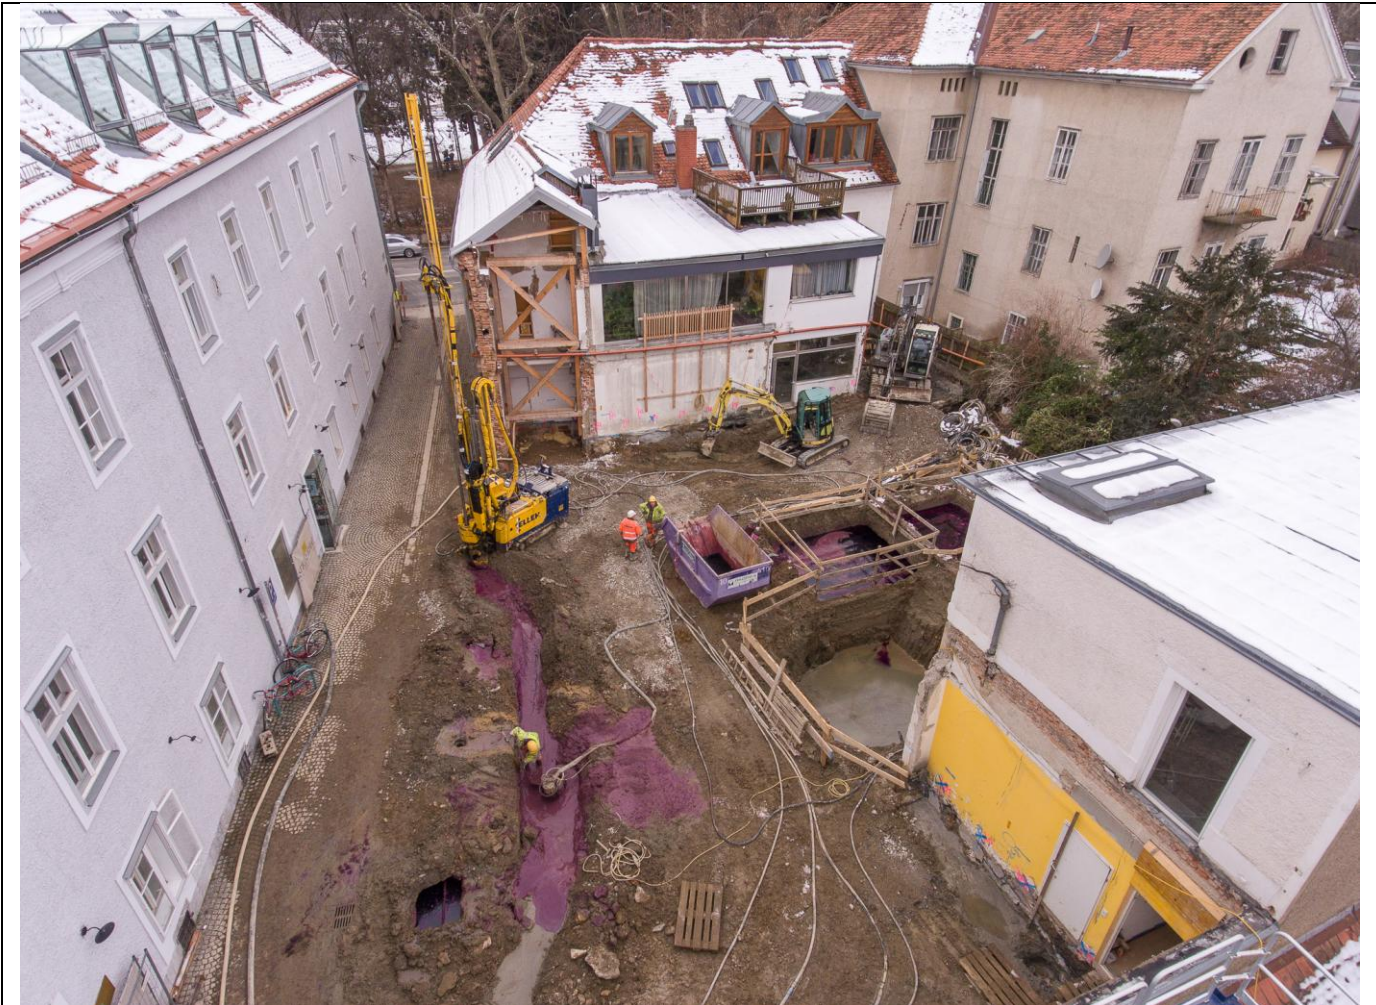
A picture of the site. Works are conducted below former washing machines. Backflow deeply covered purple by KMnO_4

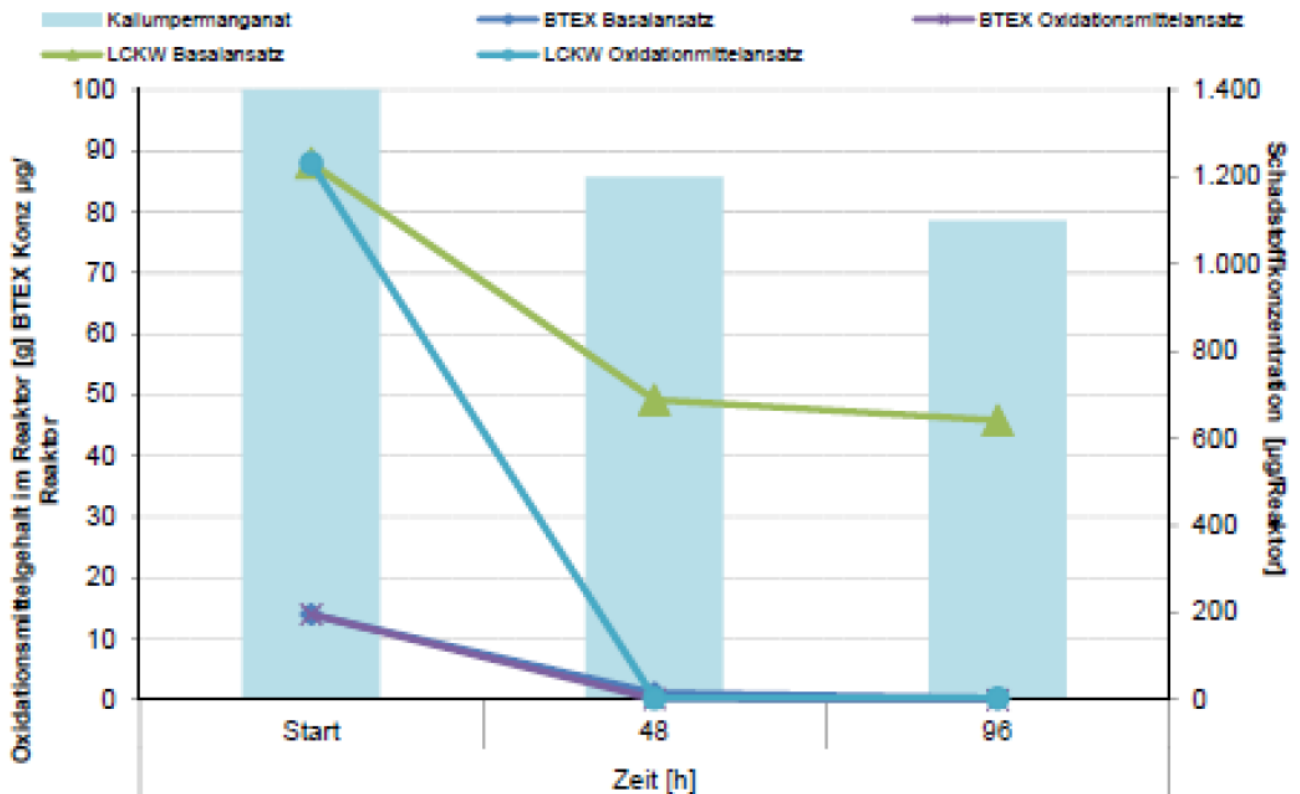
Oxidant consumption (KMnO_4) and contaminant reduction (CHC and BTEX) during 96 hr reactor test

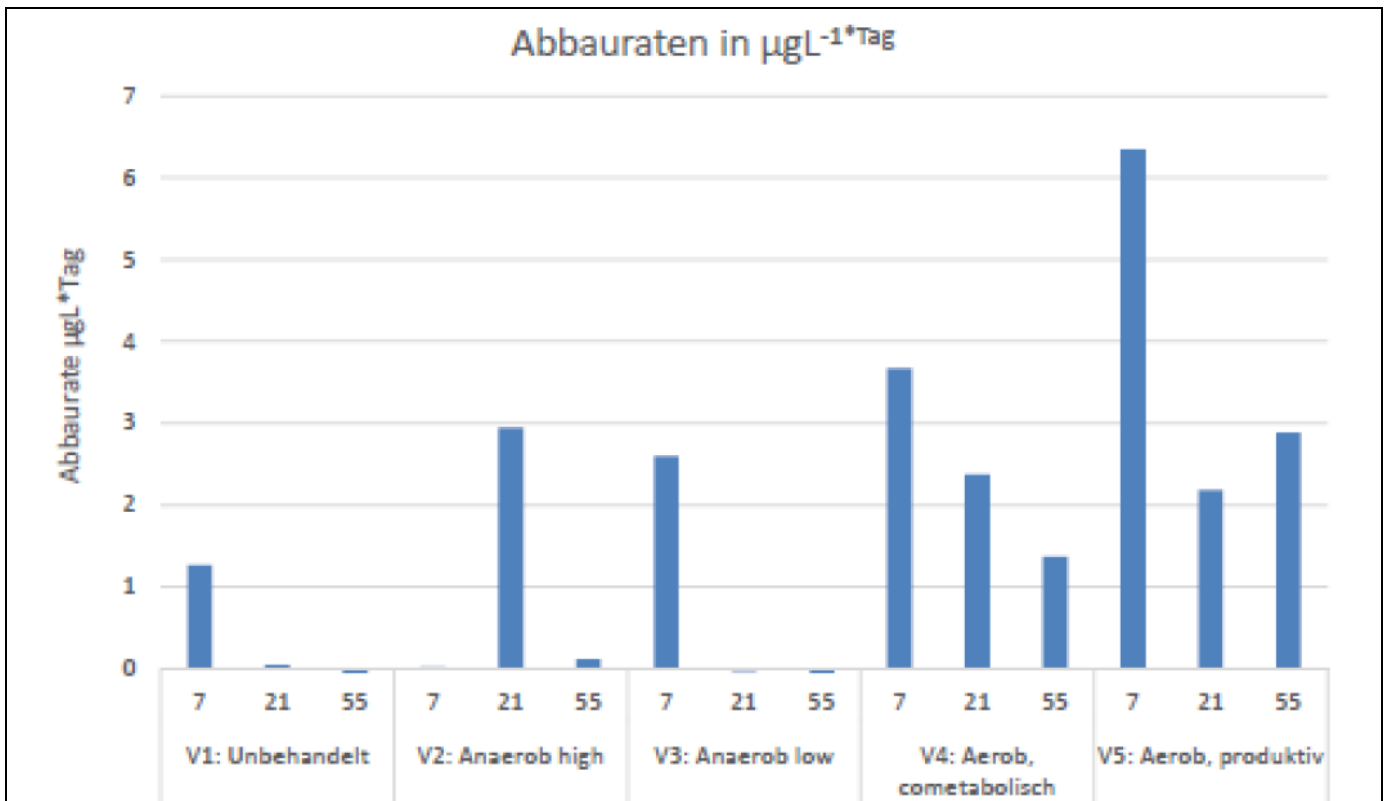
Degradation rates for total chlorinated aliphatic hydrocarbons (CHCs) using anaerobic and aerobic substrates

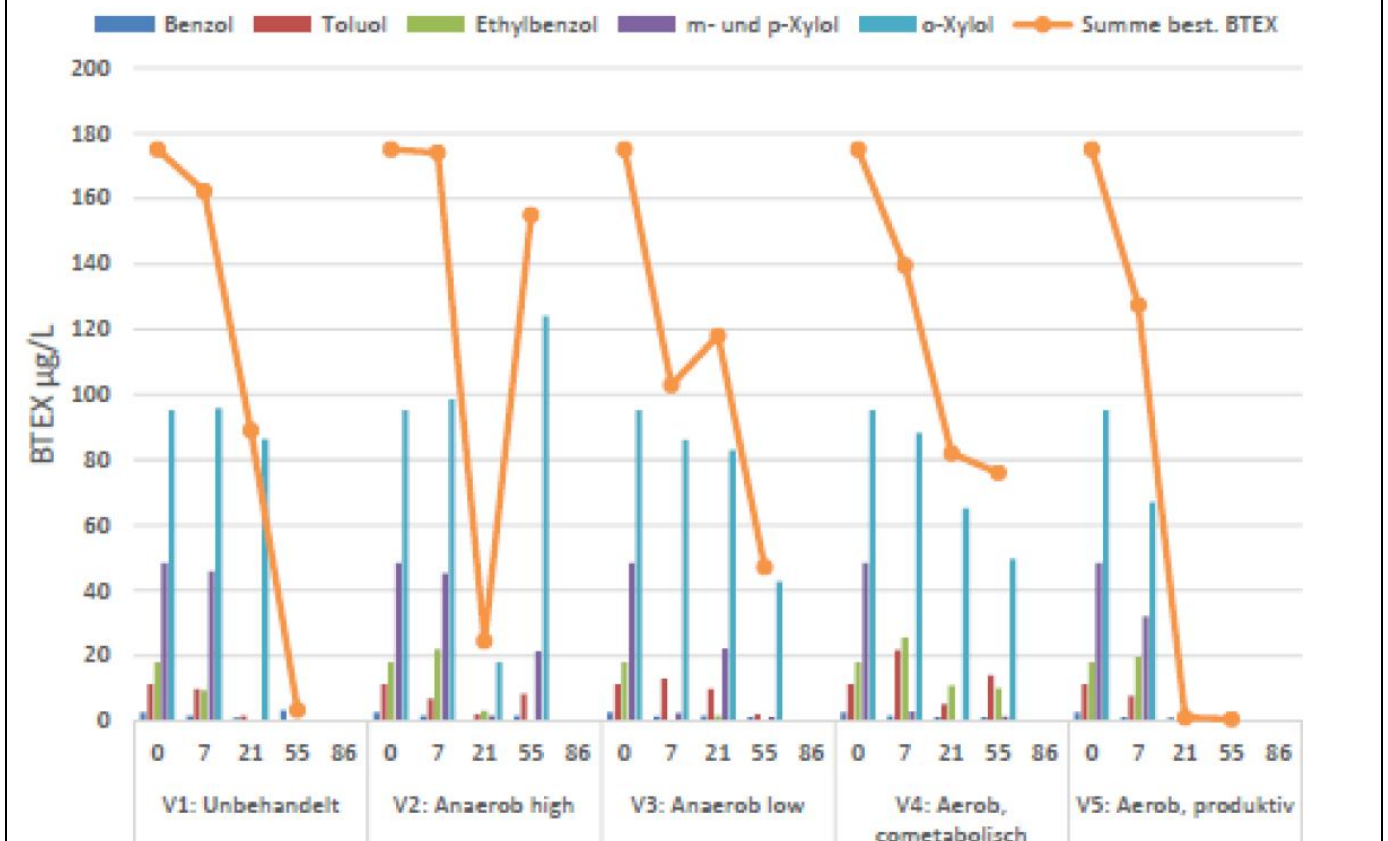
Degradation rates for aromatic petroleum hydrocarbons (BTEX) using anaerobic and aerobic substrates

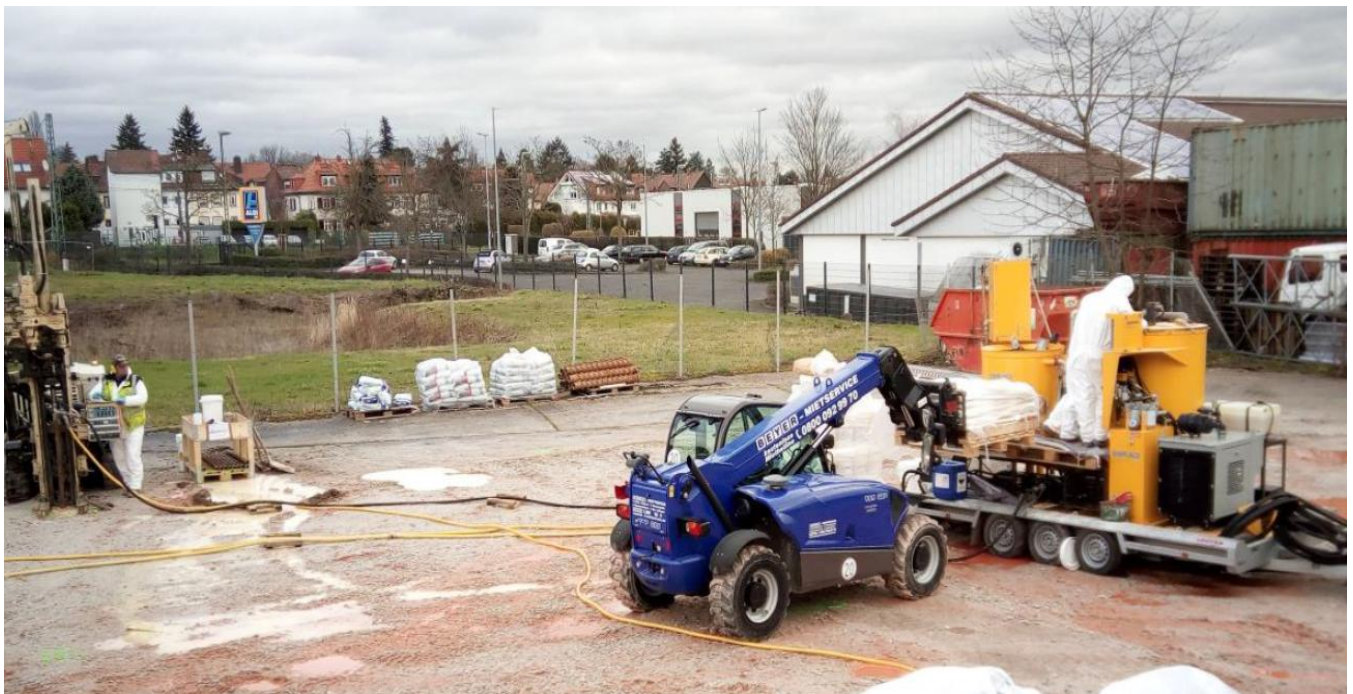
High pressure injection/fracturing/ and mixing equipment used for fracture-emplacment of persulfate-peroxide oxidant slurry into subsoils through direct push drill holes

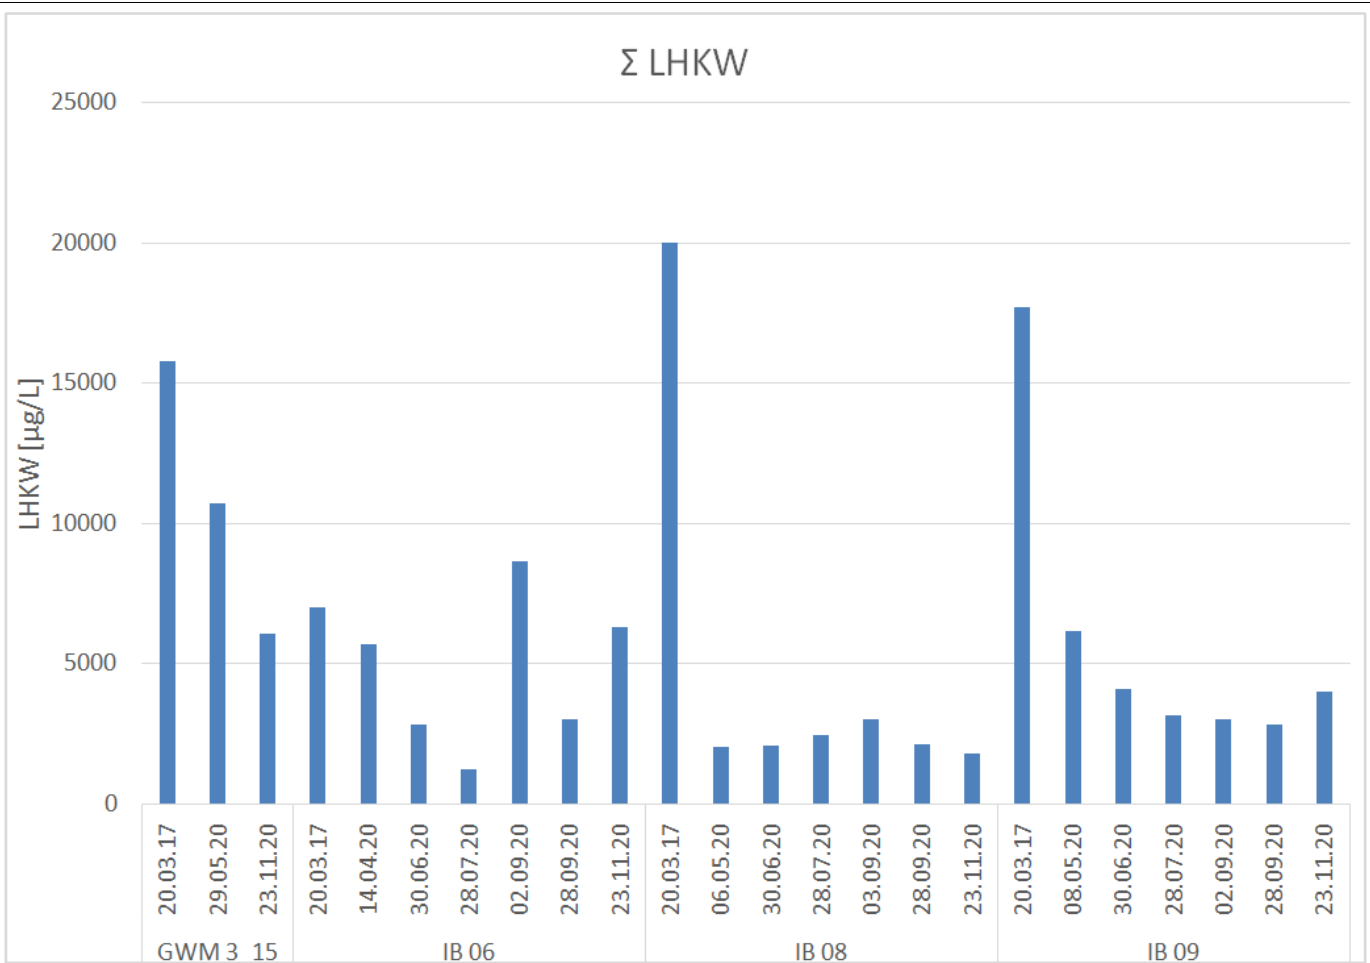
Typical CHC concentration profiles for: perimeter groundwater monitoring well GWM3_15; plume area wells IB05 (with rebound); plume area well IB07 (no rebound) after oxidant injection.

- 1 well showed no contaminant rebound
- 6 wells showed moderate rebound effects (< 25 % of pre-treatment concentrations)
- 8 wells showed strong rebound effects (> 50 % of pre-treatment concentrations)

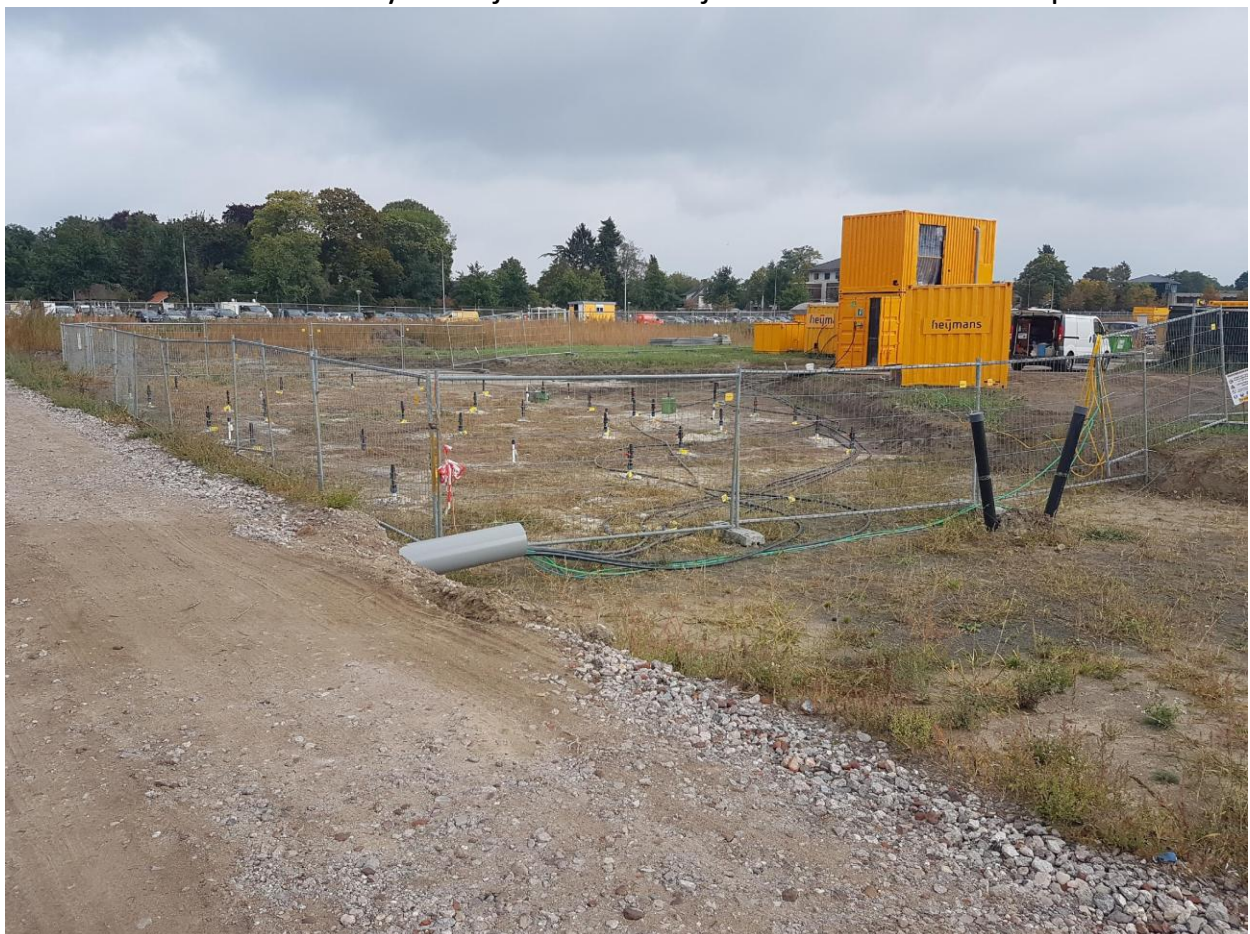
Overview injection filters in source zone

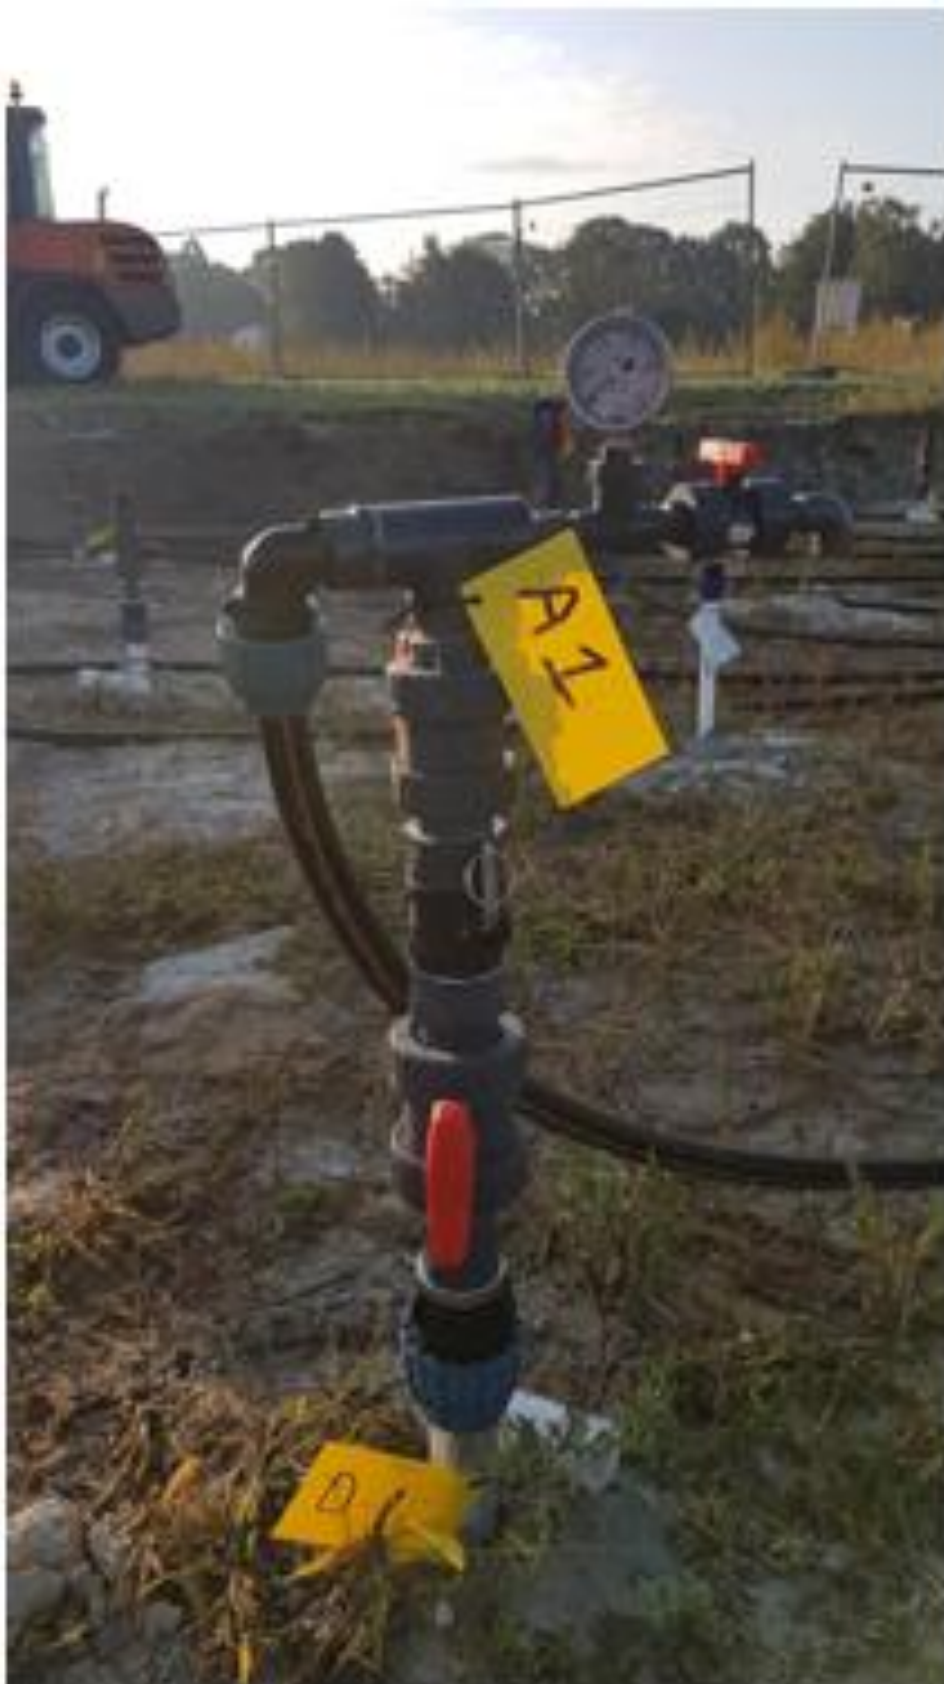
Detail injection well manifold

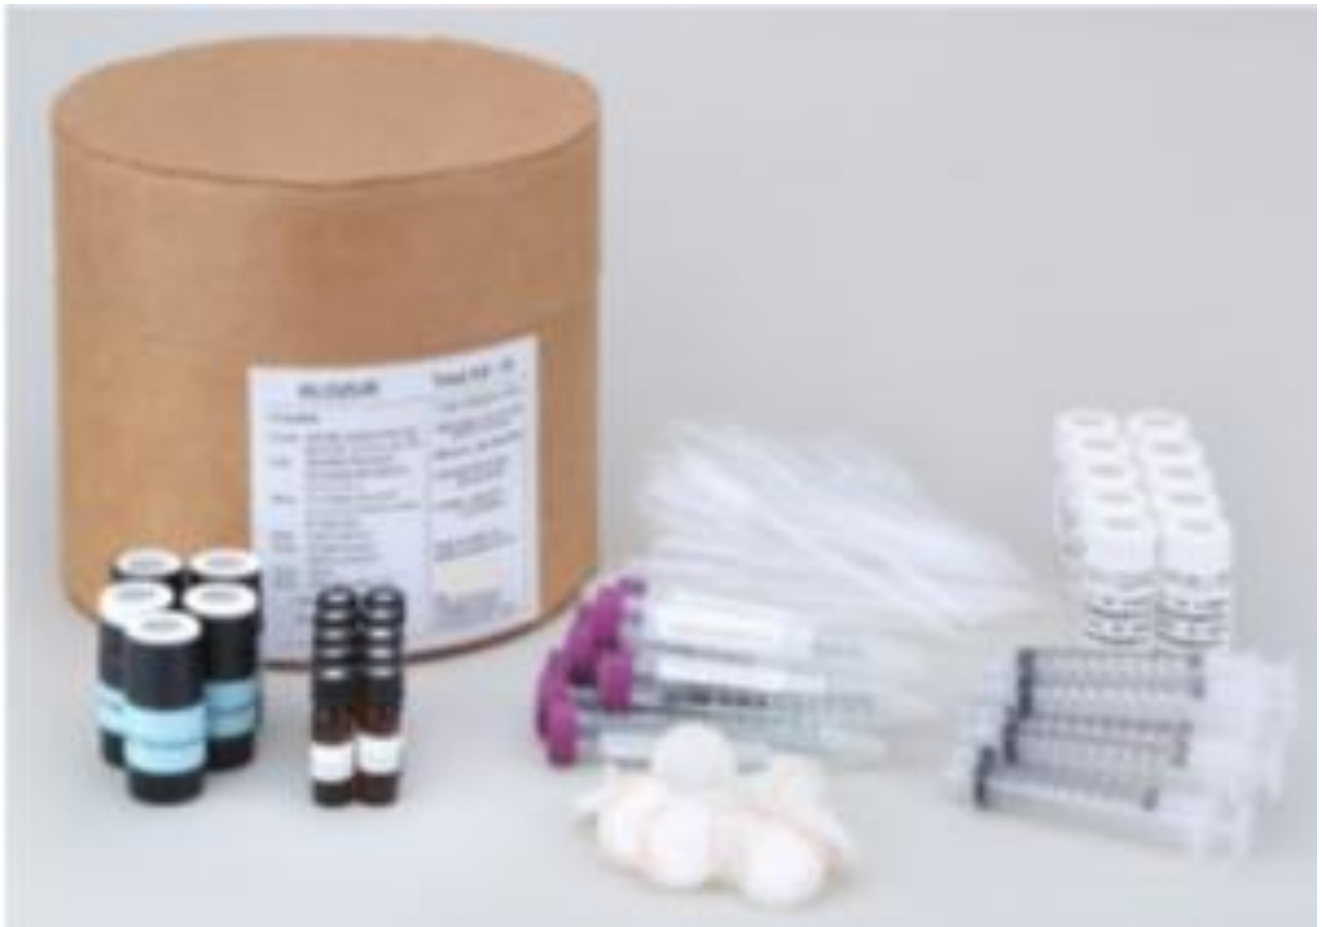
Klozur Field test kits

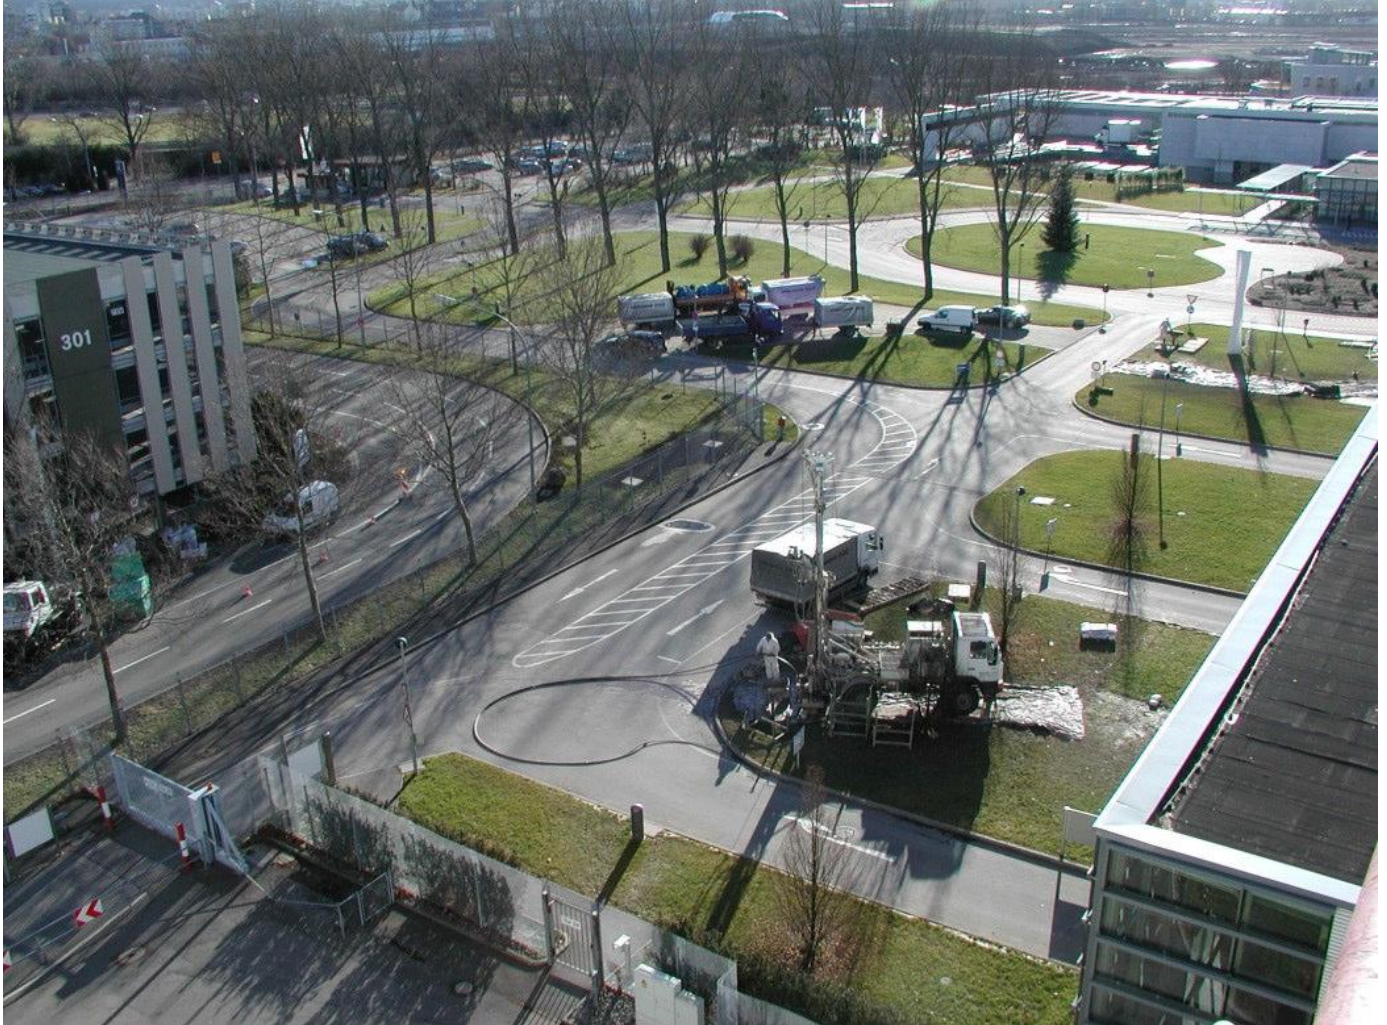
Drilling work for the remediation wells in front of building 25/1

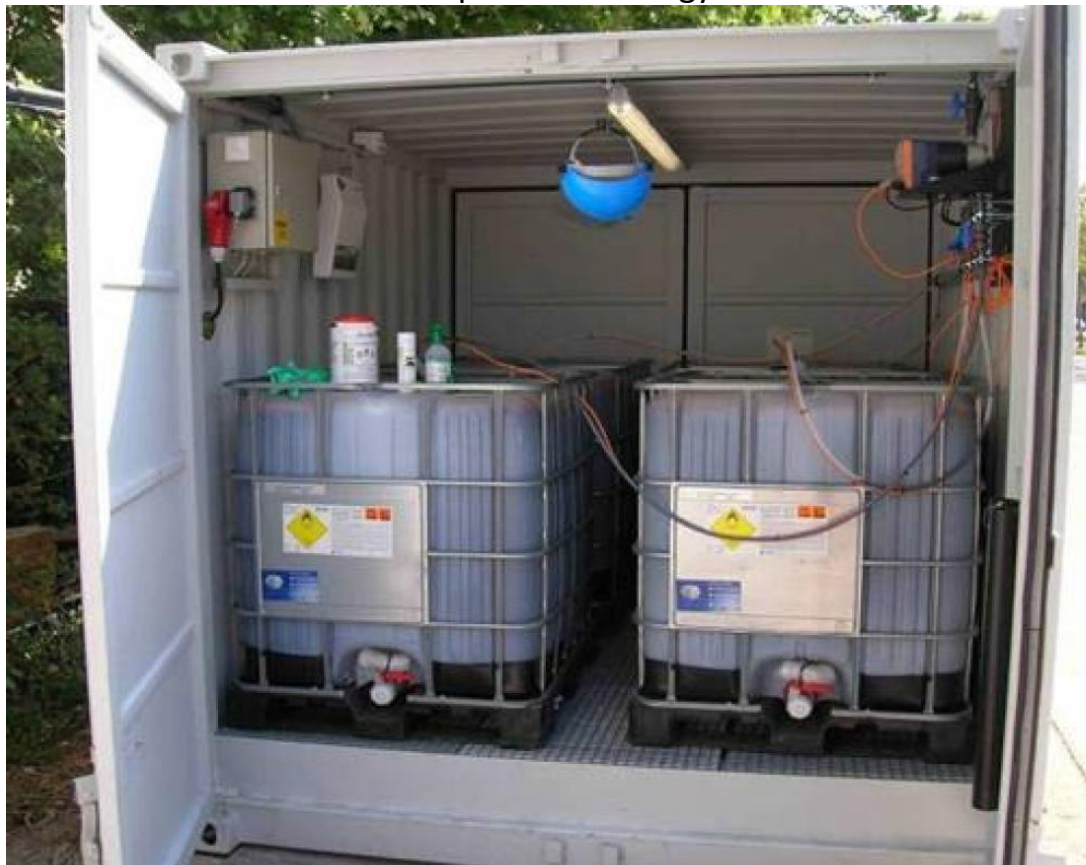
ISCO dosing station
